ENGINEER DESIGN TEST OF
5.56-MM FABRIQUE NATIONALE MACHINE GUN,

MODEL MILIMI

FINAL LETTER REPORT

SUBJECT: Final Letter Report of Engineer Design Test of 5.56-MM
Fabrique Nationale Machine Gun, Model MILIMI, TECOM Project
No. 8-WE-400-SAW-003, APG-MT-4564

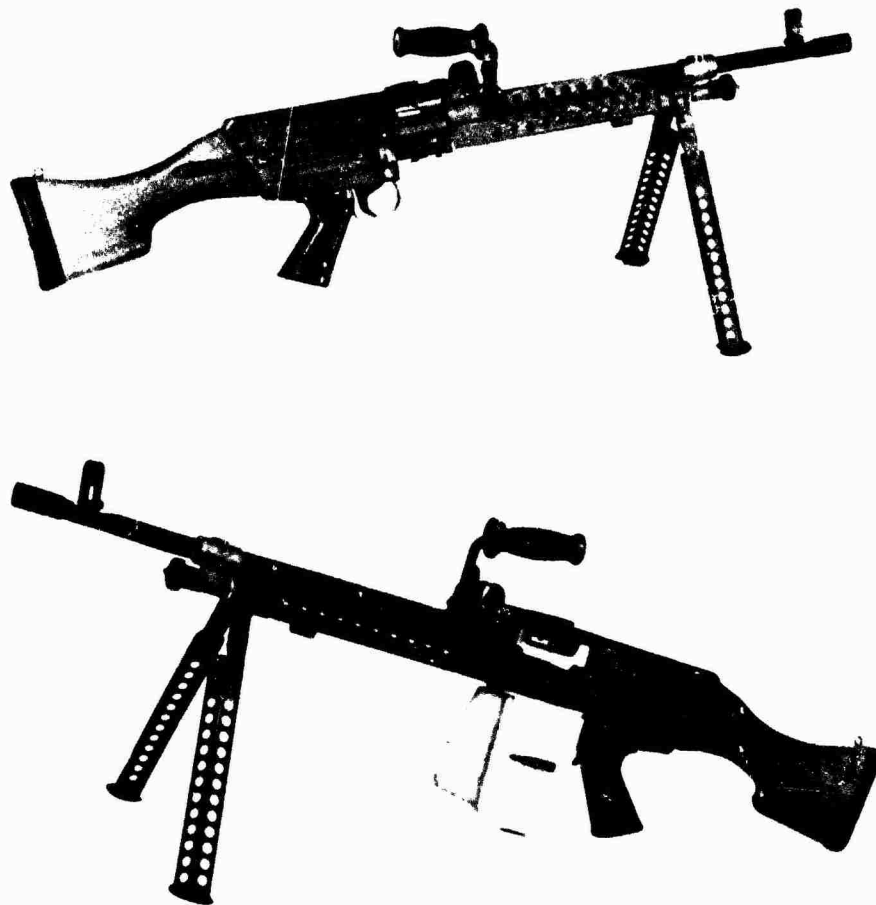
Figure 1.1-1 shows the second design configuration weapon tested at the US Army Infantry Board. The external view of this weapon differs only slightly from the first design configuration weapon tested at Aberdeen Proving Ground.

Figure 1.1-1: Right Side View (TOP) and Left Side View (BOTTOM) of the 5.56-MM Fabrique Nationale (FN-Belgian) Machine Gun, Model MILIMI. (Second Design Configuration.)

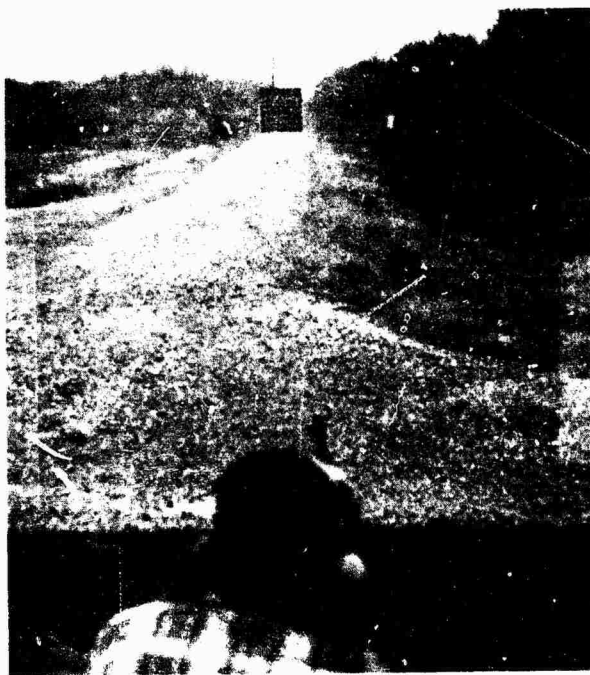
The effects of gunsmoke on target obscuration and weapon signature were evaluated photographically. The results are shown in Figure 1.2-6. These views were taken directly behind the weapon with the target grid located 100 meters downrange (target obscuration) and from a camera located 20 feet to the right of the downrange target (weapon signature).. Both views were of the same 25-round burst, taken simultaneously, immediately after completion of firing. Wind velocity at time of firing was from right to left of the shooter, at 4 mph. Although the apparent amount of smoke is greater when viewed from downrange, the effect of having a lighter over-all background when viewed from the firing position might account for the visual difference. The tracer projectile flight paths were visible to the shooter when firing from the prone, bipod-supported position.

Figure 1.2-6: Effects of FV Machine Gun Smoke on Target Obscuration (TOP) and Weapon Signature (BOTTOM) at 100 Meters Range. Target Grid Is 12 Inches (1-Inch Wide Grid Lines).
